Forensic Assessments of the Nuclear Propulsion Plants of the Submarines HMS *Tireless* and RF Northern Fleet *Kursk*

John H Large

Large & Associates, Consulting Engineers

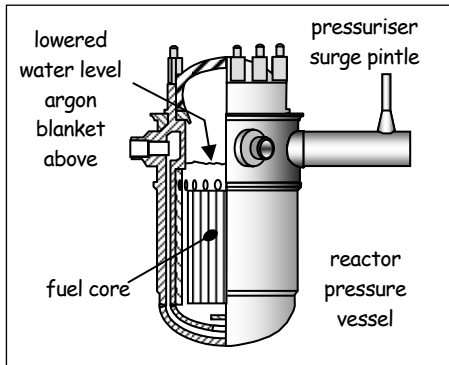
If the fault had been allowed to develop further then *Tireless* would have been at very real risk of catastrophic failure of the surge pipe junction which, being located inboard of the primary circuit isolation valves, could allow the reactor pressure vessel to rapidly depressurise and starve of coolant. Uncontrolled loss of coolant at this locality could have resulted in boiling of the coolant remaining in the reactor vessel, overheating of the nuclear fuel (even with the nuclear process shut down because of the continuing residual heat from fuel decay), the possibility of fuel melting and, in the extreme, a violent explosion leading to a radioactive release in less than one hour.^{3,4}

5 RPV and Surge Pipe Pintle

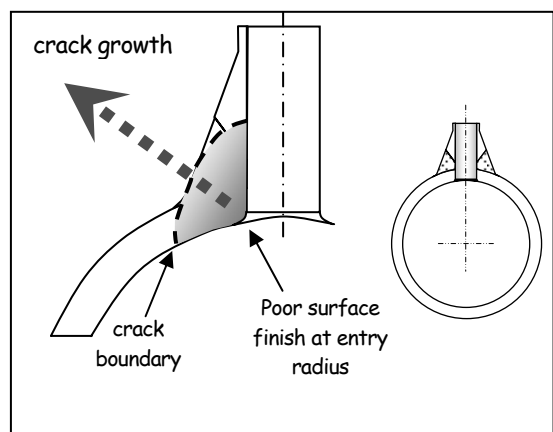
6 Pressuriser Surge Line Pintle showing 1 of 2 thermally induced cracks

CNNRP concluded upon fuller inspection of the removed trepanned section, the cracking to have arisen from thermal fatigue resulting from slugs of cooler water cycling in and out of the mouth of the pressuriser surge pipe⁹ over many years of operation, although the final detailed results of the analysis of the removed pintle-main pipe section were never revealed to the Expert Panel advising the Government of Gibraltar.¹⁰ In the absence of proof otherwise, it may have been that the failure cause was more complex, resulting from a combination of thermal fatigue¹¹ and thermal striping,^{12,13} the latter being relatively short-term in development. Another possible contributory factor to the cracking was the very poor (grooved) finish of what should have been a smooth, radius edge of the main pipe cut-out leading into the surge pipe, possibly containing latent crack initiators that could have developed over years of service.

Working up the new repair plan and the decision to replace the pintle design with a one-piece forged swept branch connector (a *Sweepolet*) further delayed progress on *Tireless* until November, thereafter there was stay-over whilst another *Trafalgar* class submarine was adopted as the lead boat to demonstrate the ease and validity of repair at the fully equipped Devonport Dockyard in the UK. *Tireless* was eventually fitted with the *Sweepolet*, passed NDE and the 'cold' hydro¹⁶ test, being readied for nuclear power operations to leave the Port of Gibraltar on 8 May 2001, almost a year to the day that she ignominiously limped into Gibraltar under her emergency diesel power.

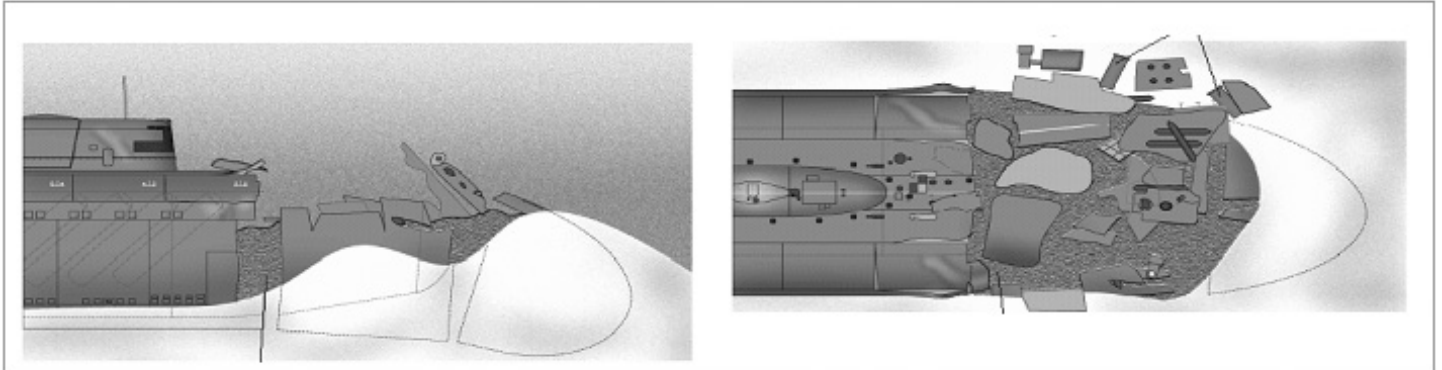
forward pressure hull (10 x 8m area) and outer casing and, at the same time, sending a reverberating hammer blow through the compartments towards the stern. Structural and flood bulkheads N° 2 and 3 were ripped through, with N° 4 buckling and subsequently collapsing under the hydrostatic flooding loads. N° 5, the forward reactor compartment bulkhead, and the remaining bulkheads through to the ninth compartment remained intact.¹⁷

7 Wreck of the *Kursk* – bow flood hull housing the forward seeking sonar has been displaced, the various cylinders are gas storage bottles, and the entire top section of the pressure hull of No 1 and No 2 compartments has been blown away

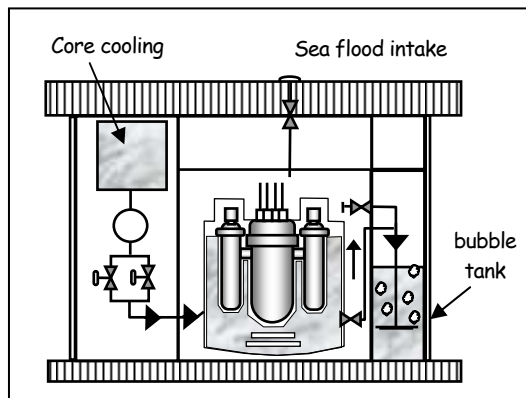
8 Integrated PWR plant (1 of 2) in Compartment No 6 showing schematic of emergency cooling systems

First, the capacity of the passive heat dissipation and emergency core cooling systems to protect the reactor cores was assessed.²¹ Observations for the range ship *Pyotr Velikiy* gave *Kursk* to be making a little over 6 knots on its torpedo run and, rigged in combat role, her reactors would have been powered to include for at least a 15% steam dump to the condensers, so all in all about 90MW_t for each reactor at the instant of boat electrical supplies being tripped out and, once and if this had been coped with, thereafter a residual heat of decay of about 10 to 15MW_t reducing (initially rapidly and then slowing over weeks) until equilibrium *thermal rollover* had been reached. The post-incident dissipation of the reactor core residual heat, with the reactors tripped and once that the turbines had spun down and the condensers lost vacuum, in the absence of any energised core cooling systems was considered to be the most challenging phase. This had been analysed by the Russian technicians earlier with the outcome suggesting that some parts of the fuel cores would have been unlikely to have survived the associated temperature excursions without damage. So with the condition of individual fuel element containments (cladding) doubtful but in the absence of any radioactivity emanating from within the reactor compartment, the assessment was that the pressure hull and bulkhead containment in the vicinity of the reactor compartment remained sound, with at least one other containment level (either the shield tank and/or primary circuit) intact.
