Forensic Assessments of the Nuclear Propulsion Plants of the Submarines HMS *Tireless* and RF Northern Fleet *Kursk*

John H Large

Large & Associates, Consulting Engineers

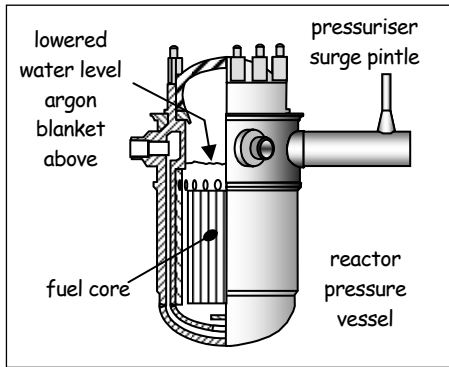
The fault in the reactor primary circuit of *Tireless* was first detected by the *leak-before-break* systems on board the submarine when she was submerged. The leak was located in the immediate locality of the welded pintle tee-junction of the pressuriser surge pipe and the main outlet pipe feeding from the reactor to one of the steam generators. The reactor was shut down following prescribed procedures, and the leakage rate estimated. It was then decided at high level within Ministry of Defence (MoD) and communicated back to the boat that the reactor could be restarted and the boat continue nuclear operations. However, after a few hours of running the leakage

If the fault had been allowed to develop further then *Tireless* would have been at very real risk of catastrophic failure of the surge pipe junction which, being located inboard of the primary circuit isolation valves, could allow the reactor pressure vessel to rapidly depressurise and starve of coolant. Uncontrolled loss of coolant at this locality could have resulted in boiling of the coolant remaining in the reactor vessel, overheating of the nuclear fuel (even with the nuclear process shut down because of the continuing residual heat from fuel decay), the possibility of fuel melting and, in the extreme, a violent explosion leading to a radioactive release within a few minutes.^{2,3}

5 RPV and Surge Pipe Pintle

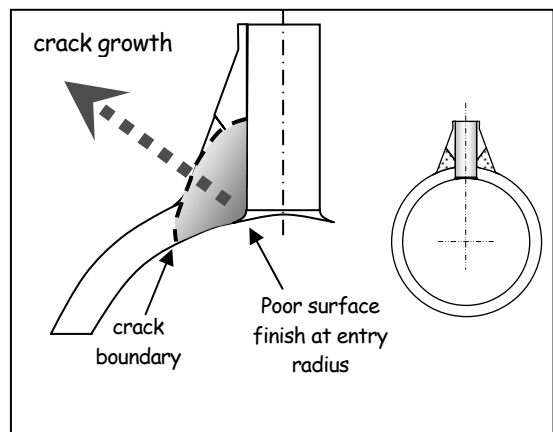
In fact, throughout this cool down and preparatory period the assumption had been that the fault was a single crack originating and confined within the pintle weld, that had grown from a flaw overlooked in the original build NDE radiographed certification of the weld and, importantly, that for the repair it would be sufficient to remove and replace just the pintle of the smaller diameter pressuriser surge pipe. However, once access for an in-pipe cctv viewing system had been established, the cracking was discovered to be very much more extensive, comprising two distinct centimetres long vertical fractures originating in the parent metal of the larger primary circuit pipework, and spreading upwards and outwards into the wall of the main pipe and pintle weld. The extent of the cracking required approximately one-quarter of the uppermost section of the primary circuit pipe at

6 Pressuriser Surge Line Pintle showing 1 of 2 thermally induced cracks

CNNRP concluded upon fuller inspection of the removed trepanned section, the cracking to have arisen from thermal fatigue resulting from slugs of cooler water cycling in and out of the mouth of the pressuriser surge pipe⁸ over many years of operation, although the final detailed results of the analysis of the removed pintle-main pipe section were never revealed to the Expert Panel advising the Government of Gibraltar.⁹ In the absence of proof otherwise, it may have been that the failure cause was more complex, resulting from a combination of thermal fatigue¹⁰ and thermal striping,^{11,12} the latter being relatively short-term in development. Another possible contributory factor to the cracking was the very poor (grooved) finish of what should have been a smooth, radius edge of the main pipe cut-out leading into the surge pipe, possibly containing latent crack initiators that could have developed over years of service.

the cracked junction to be trepanned out resulting in the need for a complete in situ reconstruction of the surge pipe junction.

Working up the new repair plan and the decision to replace the pintle design with a one-piece forged swept branch connector (a *Sweepolet*) further delayed progress on *Tireless* until November, thereafter there was stay-over whilst another *Trafalgar* class submarine was adopted as the lead boat to demonstrate the ease and validity of repair at the fully equipped Devonport Dockyard in the UK. *Tireless* was eventually fitted with the *Sweepolet*, passed NDE and the cold hydro test, being readied for nuclear power operations to leave the Port of Gibraltar on 8 May 2001, almost a year to the day that she ignominiously limped into Gibraltar under her emergency diesel power.
