Forensic Assessments of the Nuclear Propulsion Plants of the Submarines HMS *Tireless* and RF Northern Fleet *Kursk*

John H Large

Large & Associates, Consulting Engineers

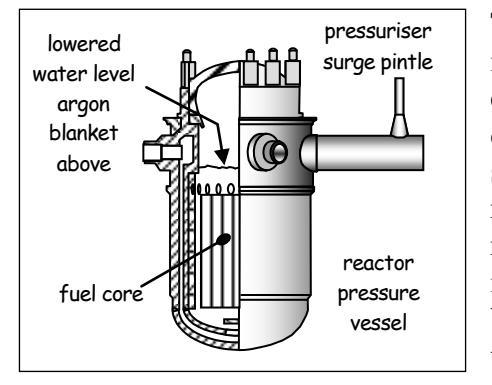
The fault in the reactor primary circuit of *Tireless* was first detected by the *leak-before-break* systems on board the submarine when she was submerged. The leak was located in the immediate locality of the welded pintle tee-junction of the pressuriser surge pipe and the main outlet pipe feeding from the reactor to one of the steam generators. The reactor was shut down following prescribed procedures, and the leakage rate estimated. It was then decided at high level within Ministry of Defence (MoD) and communicated back to the boat that the reactor could be restarted and the boat continue nuclear operations. However, after a few hours of running the leakage

If the fault had been allowed to develop further then *Tireless* would have been at very real risk of catastrophic failure of the surge pipe junction which, being located inboard of the primary circuit isolation valves, could allow the reactor pressure vessel to rapidly depressurise and starve of coolant. Uncontrolled loss of coolant at this locality could have resulted in boiling of the coolant remaining in the reactor vessel, overheating of the nuclear fuel (even with the nuclear process shut down because of the continuing residual heat from fuel decay), the possibility of fuel melting and, in the extreme, a violent explosion leading to a radioactive release within a few minutes.^{2,3}

5 RPV and Surge Pipe Pintle

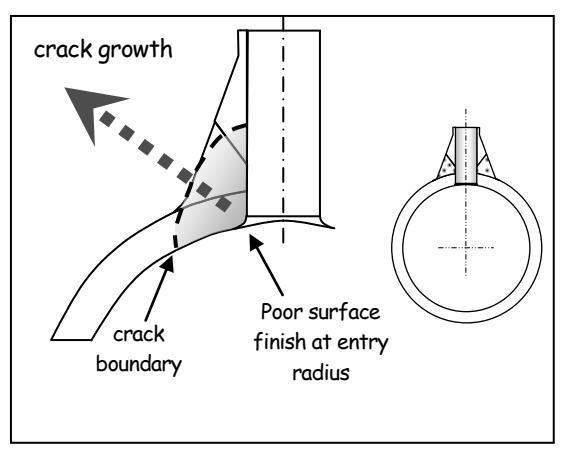
In fact, throughout this cool down and preparatory period the assumption had been that the fault was a single crack originating and confined within the pintle weld, that had grown from a flaw overlooked in the original build NDE radiographed certification of the weld and, importantly, that for the repair it would be sufficient to remove and replace just the pintle of the smaller diameter pressuriser surge pipe. However, once access for an in-pipe cctv viewing system had been established, the cracking was discovered to be very much more extensive, comprising two distinct centimetres long vertical fractures originating in the parent metal of the larger primary circuit pipework, and spreading upwards and outwards into the wall of the main pipe and pintle weld. The extent of the

6 Pressuriser Surge Line Pintle showing 1 of 2 thermally induced cracks

CNNRP concluded upon fuller inspection of the removed trepanned section, the cracking to have arisen from thermal fatigue resulting from slugs of cooler water cycling in and out of the mouth of the pressuriser surge pipe⁸ over many years of operation, although the final detailed results of the analysis of the removed pintle-main pipe section were never revealed to the Expert Panel advising the Government of Gibraltar.⁹ In the absence of proof otherwise, it may have been that the failure cause was more complex, resulting from a combination of thermal fatigue¹⁰ and thermal striping,^{11,12} the latter being relatively short-term in development. Another possible contributory factor to the cracking was the very poor (grooved) finish of what should have been a smooth, radius edge of the main pipe cut-out leading into the surge pipe, possibly containing latent crack initiators that could have developed over years of service.

Working up the new repair plan and the decision to replace the pintle design with a one-piece forged swept branch connector (a *Sweepolet*) further delayed progress on *Tireless* until November, thereafter there was stay-over whilst another *Trafalgar* class submarine was adopted as the lead boat to demonstrate the ease and validity of repair at the fully equipped Devonport Dockyard in the UK. *Tireless* was eventually fitted with the *Sweepolet*, passed NDE and the cold hydro test, being readied for nuclear power operations to leave the Port of Gibraltar on 8 May 2001, almost a year to the day that she ignominiously limped into Gibraltar under her emergency diesel power.

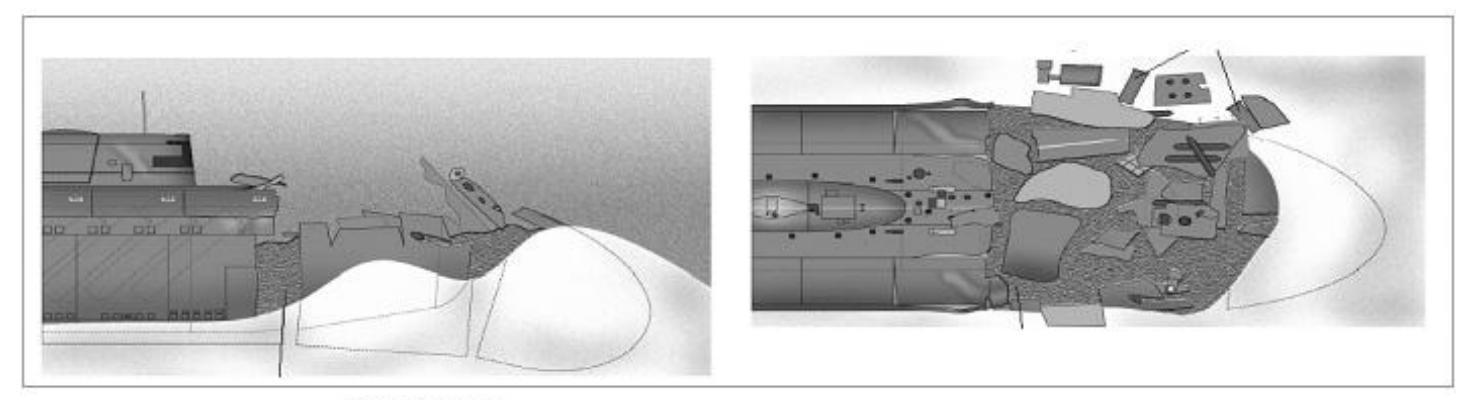
forward pressure hull (10 x 8m area) and outer casing and, at the same time, sending a reverberating hammer blow through the compartments towards the stern. Structural and flood bulkheads N° 2 and 3 were ripped through, with N° 4 buckling and subsequently collapsing under the hydrostatic flooding loads. N° 5, the forward reactor compartment bulkhead, and the remaining bulkheads through to the ninth compartment remained intact.¹⁵

7 Wreck of the *Kursk* – bow flood hull housing the forward seeking sonar has been displaced, the various cylinders are gas storage bottles, and the entire top section of the pressure hull of No 1 and No 2 compartments has been blown away
