REGINA -v- MS \*\*\*\*\* \*\*\*\*\*

DRIVING WITHOUT DUE CARE AND ATTENTION – 7 DECEMBER 2003

SUMMARY REPORT OF INSPECTION  
OF THE  
SCENE OF THE INCIDENT  
&  
\*\*\*\*\*'S VEHICLE

REPORT REF N<sup>o</sup> R3069-A1

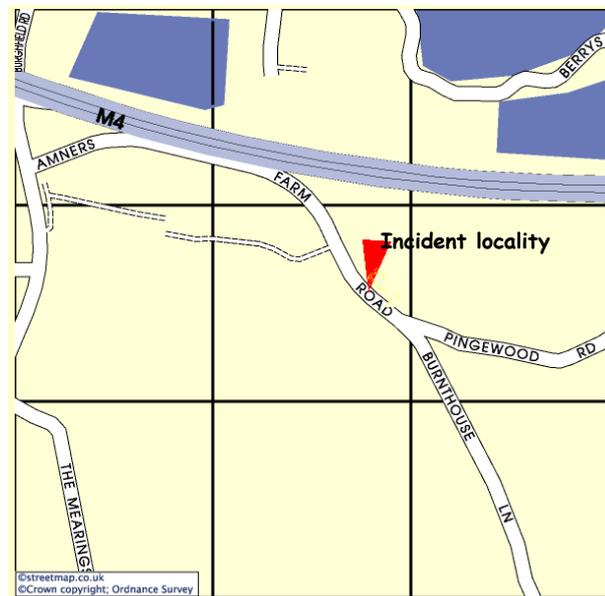
3.2 The road is not illuminated, it has raised and hard kerbs on both sides and a centre dashed line marking, with no significant camber to either carriageway. Road width is approximately 6m with equal carriageways of 3m width. In the locality

of the incident, over a linear distance of 100m running north-west from the junction with Burnthouse Lane and Pingewood Road, there is a 0.6% incline running up to the north-west to a slow right-hand bend.

3.3 There is a shallow drainage ditch flanking the northbound carriageway, set back in the road verge approximately 1.5 to 2m from the carriageway verge, and there is a thicket hedgerow on the verge of the southbound carriageway (eastern side).

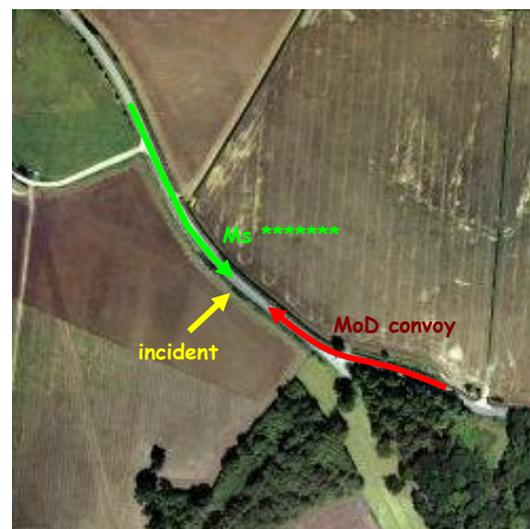
4.1 Ms \*\*\*\*\* was approaching from the north-west and had just passed by the farm track leading to Amner's Farm.

4.2 The MoD convoy was approaching north-westwards along Pingewood Road rounding the bend in the road to run along Amners Farm Road.

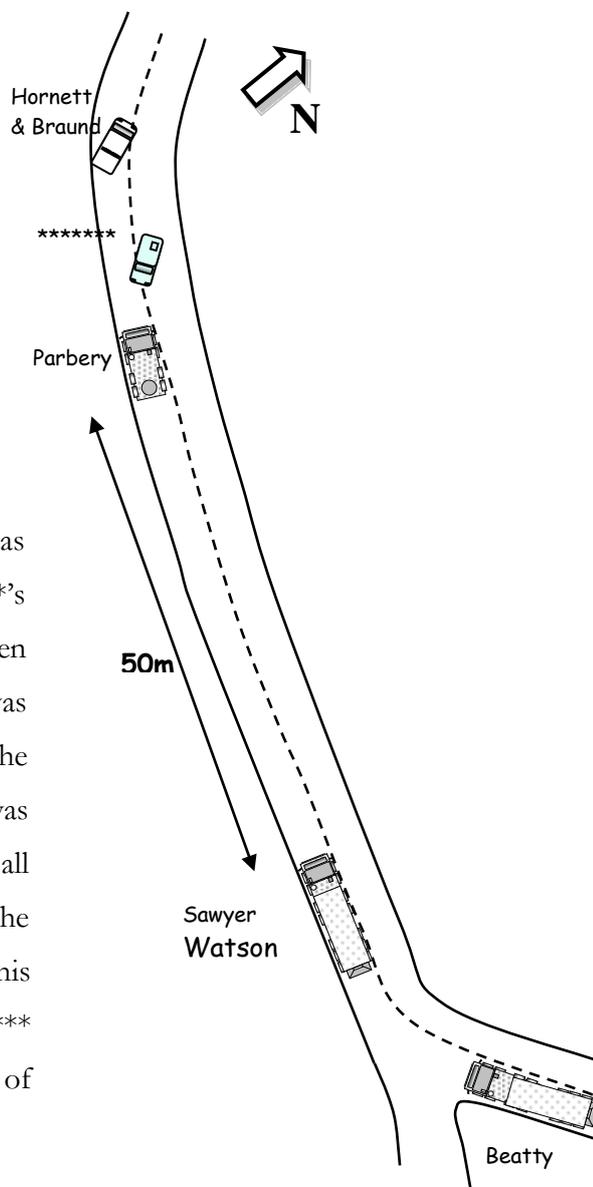
DIAGRAM 1 - VEHICLE POSITIONS

- 7.1 Diagram 1 shows that with the convoy vehicles correctly positioned.
- 7.2 Riding in the passenger seat of the second fully articulated lorry, Beatty's field of vision ahead would have been blocked by the high trailer of the articulated vehicle

- 8.2 ***i) first saw \*\*\*\*\* vehicle when it was 70ft (21m) away:*** Diagram 1 shows that the bend ahead of Parbery would have obscured a direct view of \*\*\*\*\*’s approaching vehicle, so this puts Parbery’s vehicle about 23m or so southeast of the bend for \*\*\*\*\* to have been in Parbery’s sight for the 70ft prior to the incident, thus further confirming the vehicle positions of Diagram 1.

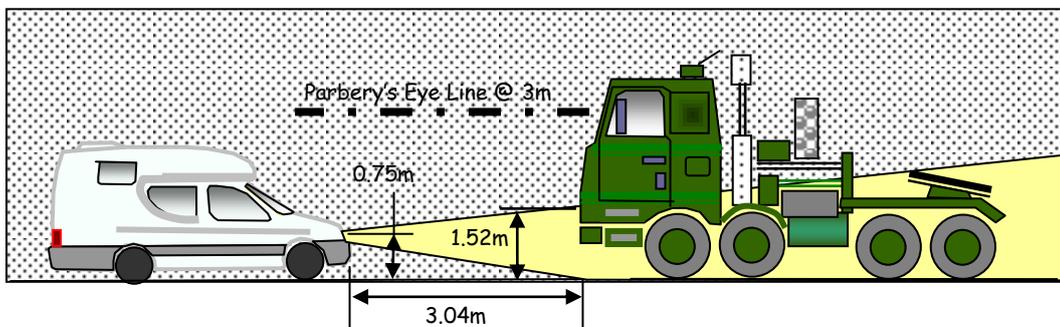
Diagram 2a - Parbery's Dazzling Claim - Main Beam On

- 8.3 ***ii) I was travelling at about 20mph due to the road conditions being dark and narrow . . . iii) when \*\*\*\*\* was about 10ft in front of us it blinded us with full beam headlights:*** I have measured the aim and spread of main and dipped beams of \*\*\*\*\*’s vehicle at points along the centre of the offside headlamp, and at various distances outset from the offside and forward of the front of the vehicle out to the distance of 3.04m (10ft).

- 8.4 The results of my measurements applied to the position and height of the cab driven by Parbery are shown in the following diagram which demonstrates that

Parbery could not have been 'blinded' by the main beam headlights of \*\*\*\*\*'s vehicle.

- 9.12 Parbery makes a point of being dazzled by \*\*\*\*\* and then only when \*\*\*\*\*'s vehicle was within 10ft (~3m) of his cab. Although Parbery's eye line (at about 3m above the road surface) would be above the cone of the powerful beam of the headlight at a distance of 10ft, the windscreen of the cab may have been picking up the dispersed or faint light that surrounds the powerful and more focussed light of the main beam.

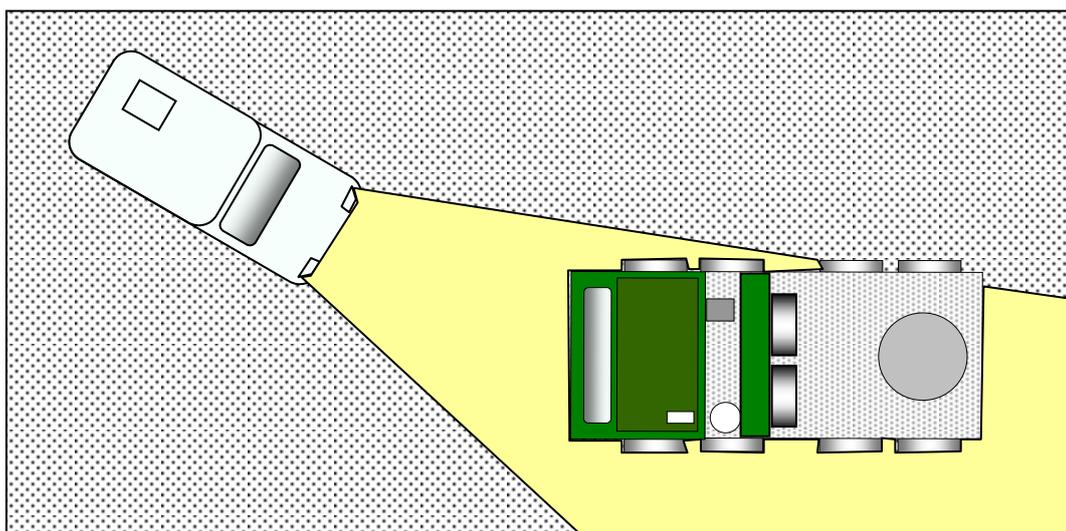
Diagram 2b - Positions According to Parbery

- 8.5 *iv) \*\*\*\*\* immediately pulled in front of our path taking up about one-third of my side of carriageway . . . v) I swerved to the nearside . . . vi) braked and steered back to the offside:* As previously noted, I have measured the carriageways from hard kerb to the painted centre line at several localities along the road. I found both northwest and southeast carriageways to be consistently of 3m width.

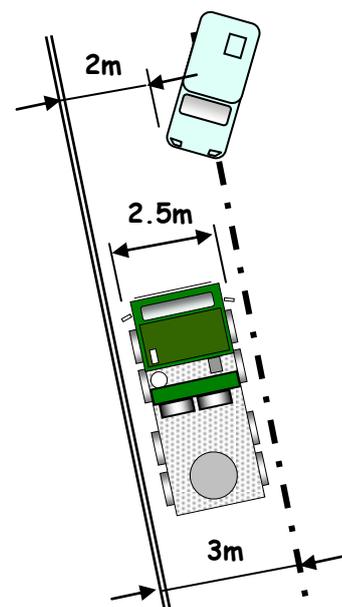
Diagram 3 Parbery's Swerve

8.6 As described by Parbery, \*\*\*\*\*'s vehicle swerved and drove across the northbound carriage occupying about one-third of its width. This would have produced a pinch point reducing the northbound carriage down to (2/3<sup>rd</sup> of 3m) 2m width.

8.7 First, to negotiate the 2.5m width tractor unit through the 2m pinch point Parbery could only have done so by steering abruptly to the left, with all four axles of the vehicle mounting the 100mm high hard kerb and riding on the soft verge. Now, I suggest, riding over the kerb would have been a very noticeable if not alarming experience in such a large vehicle and should have been recalled by Parbery when recounting the experience in making his witness statement.<sup>2</sup>

coming to rest completely blocking the carriageway. As can be reasoned from Diagram 3 if, in the first instance, \*\*\*\*\* had pulled across into one-third of the northbound carriageway and then (according to Parbery) continued on that path further into the carriageway without stopping, then the \*\*\*\*\* vehicle would have most probably collided with the front of Parbery’s vehicle or, if not, then definitely with its side.

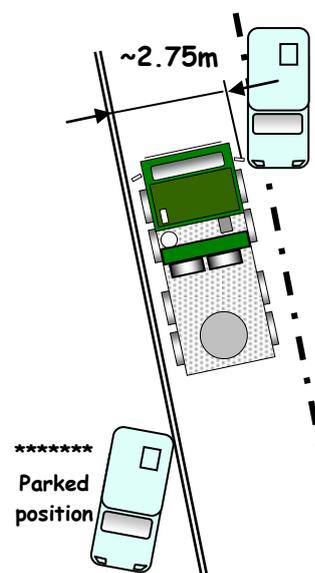
**Diagram 4 Hornett's Recount**

8.12 This is a very much different description to that given by Parbery. First, with just the offside front quarter of \*\*\*\*\*’s vehicle into the northwestbound carriageway, the pinch point is still sufficient at about 2.75m for Parbery’s vehicle to pass through unhindered and without excessive manoeuvring.

8.13 So far as Parbery’s claim that \*\*\*\*\* continued to drive into the northwestbound carriageway, more likely, as Hornett explains, \*\*\*\*\* had agreed to move the

vehicle off the road under the supervision of another officer (Tony Walton) and it was this movement underway that Parbery probably witnessed in his rear view mirror.

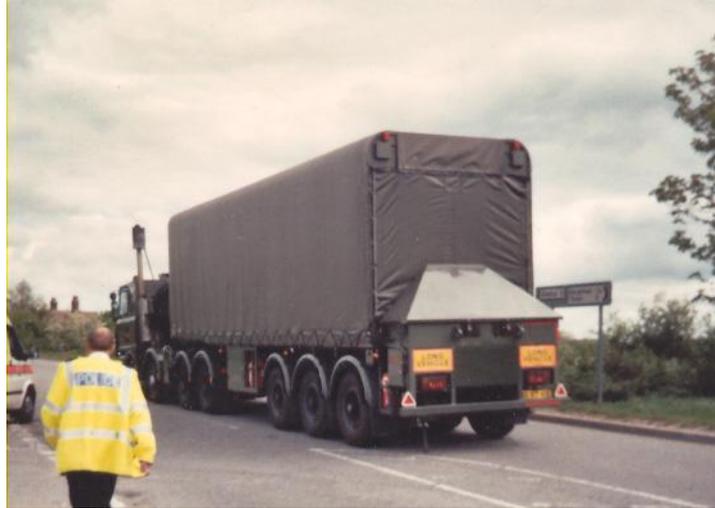
**Photograph 1** Rear of an Articulated Vehicle – Note the full height and width of the trailer unit obscuring the forward view to a vehicle behind

ahead under escort by Sawyer – see Photograph 1.<sup>1</sup>

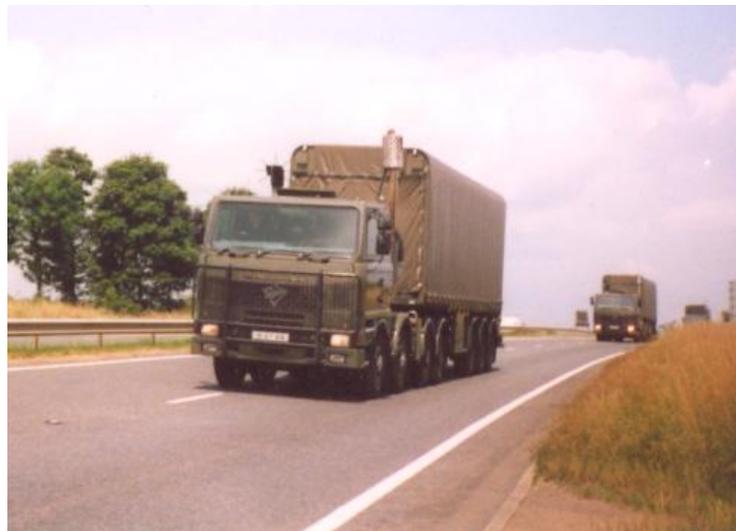
**Photograph 2** Articulated Unit – note the separation space of the following two units

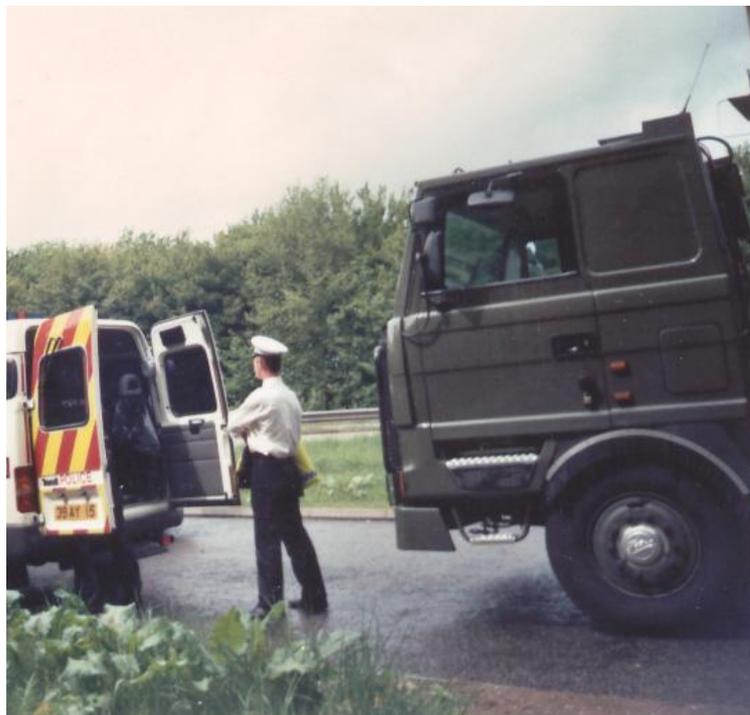
**Photograph 3** Tractor Unit – note the height of the driving position compared to the standing police officer

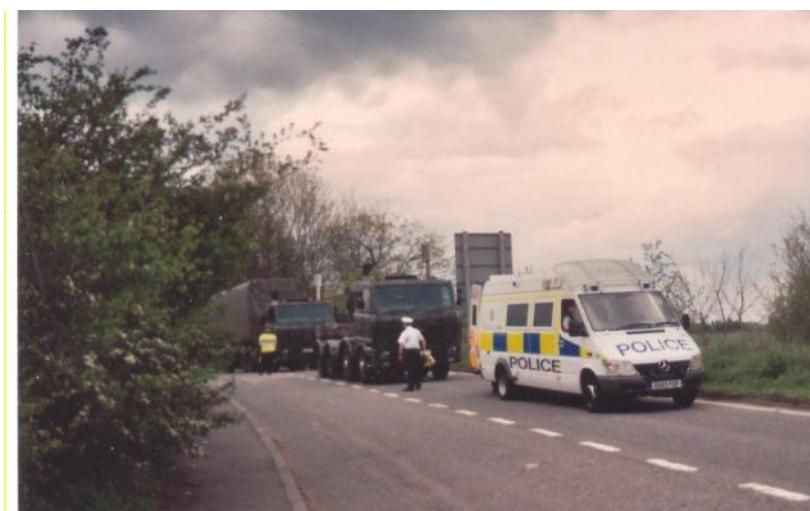
**Photograph 4** Tractor Unit with Full Articulated Unit behind

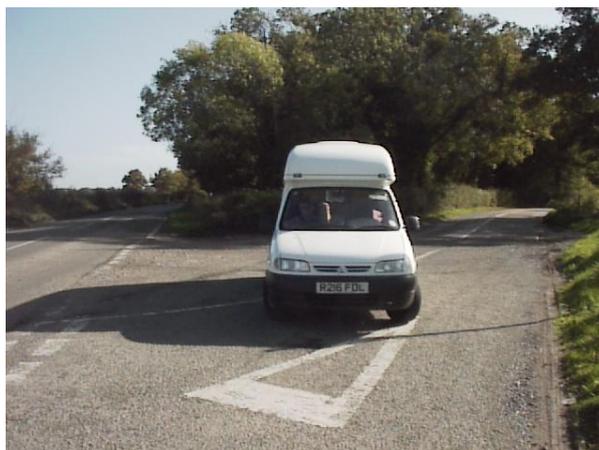
**Photograph 5** Ms \*\*\*\*\*'s Citroen RomaHome

9.2 Photograph 2 shows Ms \*\*\*\*\* in her vehicle. The vehicle is loaded (water tanks, gas supplies, etc) as it was on the evening of the incident and, as shown by the photograph, under this load distribution it is properly trimmed. Tyre pressures at the time of my inspection were at the manufacturer's recommended settings.

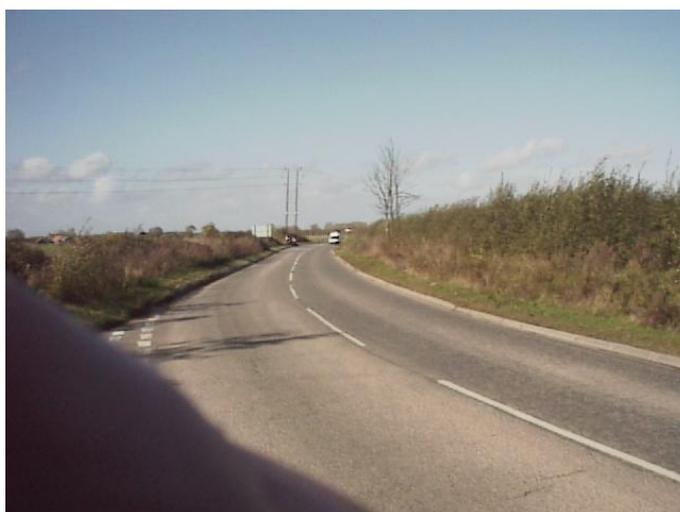
**Photograph 6** Ms \*\*\*\*\* approaching the stopping location – about where the road sign is sited to the left – viewed from the junction with Burnthouse Lane – note that the road curves off the right and the dense thicket-like hedgerow established on the right hand verge, both obscuring the approach of Ms \*\*\*\*\*'s vehicle further back from this point
