Forensic Assessments of the Nuclear Propulsion Plants of the Submarines HMS *Tireless* and RF Northern Fleet *Kursk*

John H Large

Large & Associates, Consulting Engineers

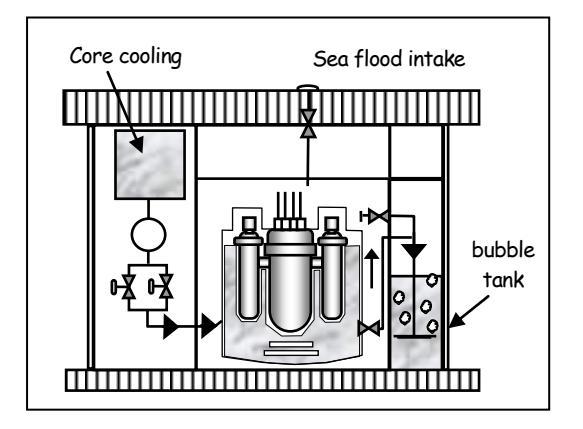
8 Integrated PWR plant (1 of 2) in Compartment No 6 showing schematic of emergency cooling systems

First, the capacity of the passive heat dissipation and emergency core cooling systems to protect the reactor cores was assessed.¹⁹ Observations for the range ship *Pyotr Velikiy* gave *Kursk* to be making a little over 6 knots on its torpedo run and, rigged in combat role, her reactors would have been powered to include for at least a 15% steam dump to the condensers, so all in all about 90MW_t for each reactor at the instant of boat electrical supplies being tripped out and, once and if this had been coped with, thereafter a residual heat of decay of about 10 to 15MW_t reducing (initially rapidly and then slowing over weeks) until equilibrium *thermal rollover* had been reached. The post-incident dissipation of the reactor core residual heat, with the reactors tripped and once that the turbines had spun down and the condensers lost vacuum, in the absence of any energised core cooling systems was considered to be the most challenging phase. This had been analysed by the Russian technicians earlier with the outcome suggesting that some parts of the fuel cores would have been unlikely to have survived the associated temperature excursions without damage. So with the condition of individual fuel element containments (cladding) doubtful but in the absence of any radioactivity emanating from within the reactor compartment, the assessment was that the pressure hull and bulkhead containment in the vicinity of the reactor compartment remained sound, with at least one other containment level (either the shield tank and/or primary circuit) intact.
